US Army Corps of Engineers

Construction Engineering Research Laboratory

Technical Report M-349 June 1984

ASSESSMENT OF THE STRESS CORROSION CRACKING OF POST-TENSIONED TENDONS AT THE JOHN DAY LOCK

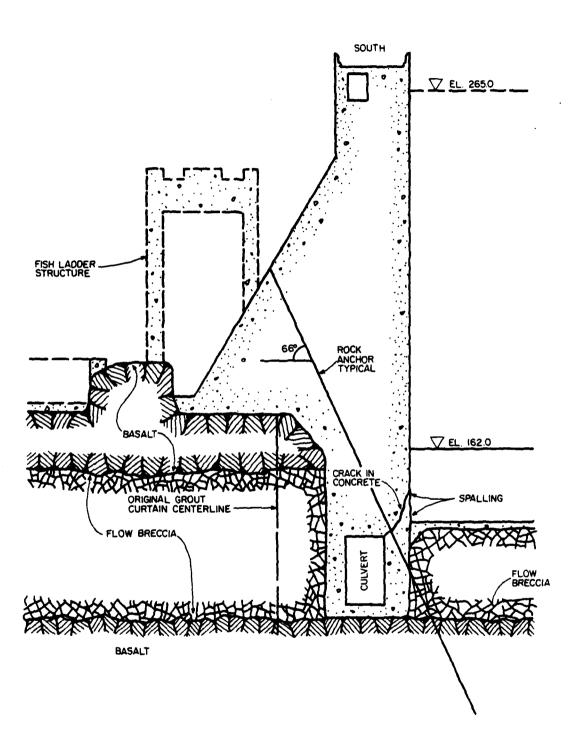
The remedial repair was successful in reducing the lock wall movement. However, each time the lock is watered, water is forced through the tops of several assemblies and intrudes into some tendon assemblies. Migration of water up the tendon assemblies can expose the tendons to several types of corrosion. The greatest concern is that stress corrosion cracking (SCC) of the highly stressed wires could cause the remedial repair system to fail.

Figure 1 shows the typical configuration of a tendon in the lock wall. The tendons are made of highstrength steel that is susceptible to SCC in many environments. The tendons were not intended to be exposed to an aqueous environment; migration of water up the tendons is the result of failure of waterproofing at some location(s) in the assembly. The point of water intrusion appears to be at the top of the tendon anchorage. At this time, the condition of a tendon's wires can be assessed only by destructive testing (i.e., by pulling a tendon out of the wall). This method is only marginally useful; although SCC in that tendon may be identified, the condition of the other tendons is still unknown. Chemical analysis of water leaving the top of the tendon assemblies after watering of the lock shows that chloride levels are low, calcium levels are high, and the pH is 11 to 12-well within the "safe" range for avoiding SCC of steel in concrete or grout environments. The remedial repairs have operated for 2 years without incident, and the intended goal of the repair system has been achieved (i.e., lock wall movement during watering and dewatering has been minimized).

Figure 1. Schematic diagram of John Day Lock and Dam showing cracks in south wall of lock and placement of post-tensioned tendons.

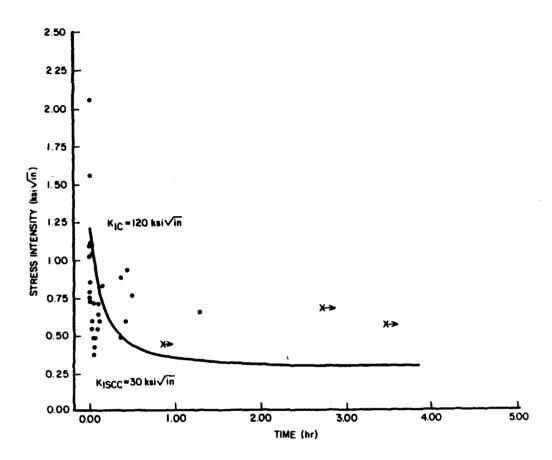
Pre-cracked samples were loaded to various stress levels in the test rings and submerged in pH 3 HCl. Ten samples failed as they were being loaded. These samples represent the value of K at a time to rupture of zero (i.e., $K_{1SCC} = K_{IC}$ at t=0). The time to failure for these tests was recorded electronically. Table 3 shows the time to failure and estimated initial stress intensity for this test. An initial crack size of 0.050 in. was assumed for all but the zero-time-to-failure specimens. Figure 2 shows a plot of the estimated stress intensity as a function of time to failure. From the

plot, the value of $K_{R'}$ can be estimated at 120 ksi $\sqrt{\text{in}}$. Some tests are still being run and are indicated by an X with an arrow pointing toward the right. At very long times (greater than 1000 hr), the value of stress intensity below which failure does not occur can be estimated to be between 15 and 30 ksi $\sqrt{\text{in}}$. This is a typical value for high-strength steels with a yield of about 200 ksi. For example, K_{1SCC} for D6AC steel with a 220-ksi yield is estimated to be 36 ksi $\sqrt{\text{in}}$ in 3 percent NaCl.²

Figure 2. Observed stress intensity versus time to failure observed in laboratory for tendon material used at John Day Lock.

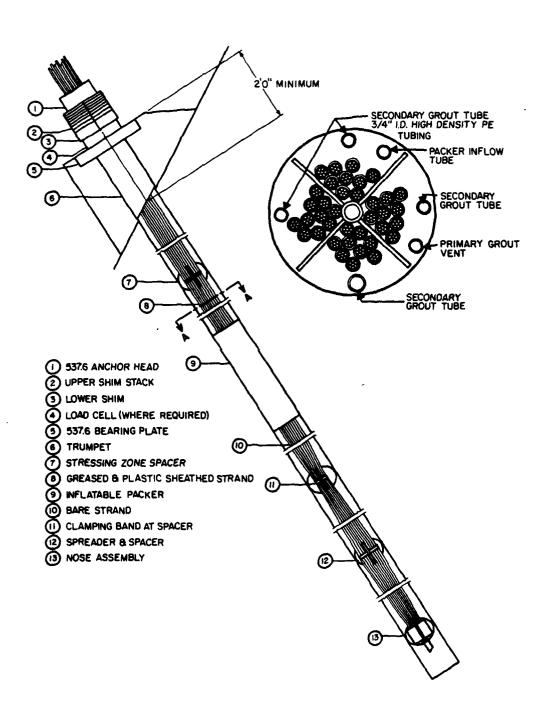
Figure 3. Schematic diagram of tendon used for remedial repair.

should be held closed; thus, the SCC problem should be eliminated in this case.

Another region of concern is the anchor head area. During normal watering and dewatering cycles, this area is exposed to alternating wet and dry conditions. Extra care must be taken to insure that all tendon components above the secondary grout are continuously coated with corrosion-inhibiting grease.

- 1. Maintain the anchor head areas by insuring that the inhibiting grease coatings are maintained periodically.
- 2. Do not reduce the stress on the tendons while the remedial repair system is operating.

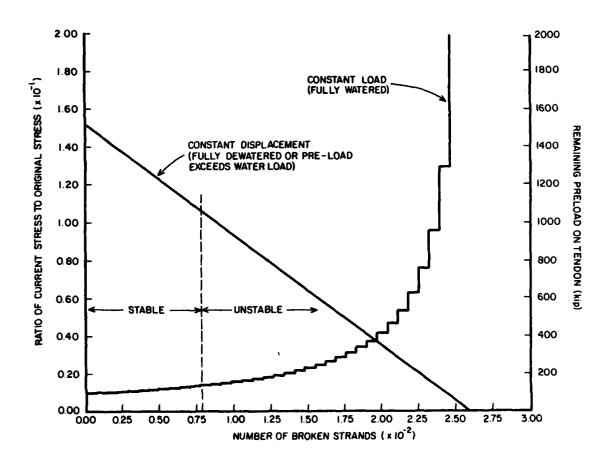
Figure 4 shows the tendon response to both constant load (assuming the pre-load equals the fully watered load) and constant displacement (fully dewatered). For the fully watered or constant load case, the ratio of current stress to original pre-stress versus number of broken strands indicates an unstable response after 11 strands (77 wires) have failed. Since the stage II crack growth rate (Figure 5) is nearly independent of stress intensity, the stress shedding from

Figure 4. The effect of number of broken strands in tendon on ratio of current stress on tendon to original stress.

failed wires will only accelerate the incubation period and not the crack growth rate. At least 77 wires would have to enter stage III crack growth while the lock is fully watered to cause catastrophic failure of a tendon. If each strand (7 wires) entered stage II crack growth sequentially, the estimated time from the first sign of failure to complete tendon failure would be about 160 to 1600 hours (i.e., 10 strands times the time to fail per wire). This estimate assumes that all wires in each strand will fail at exactly the same time. The estimated time range of 160 to 1600 hours should allow ample opportunity to dewater the lock and begin repairs. Figure 4 also shows the constant displacement response of a tendon which is representative of the lock in the dewatered state or while the pre-load exceeds the watering loads. This plot of remaining load vs. number of strands failed demonstrates that upon watering, the pre-load will drop almost 30 percent before the tendon will fail.

All tendons showing signs of water intrusion should be equipped with a load transducer for monitoring purposes. Figure 4 suggests that the amount of load drop in the tendon would be a good indication of the tendon's condition. Significant drops in load due to loss of net section area would be about 40 kips (the load per strand) and should be easily detected. For long-term maintenance, a record should be kept of the number of shims added to each tendon to maintain pre-load. If the rate of shimming in in./yr. changes or the total current displacement with respect to the 10 percent

datum measured during installation of the tendons becomes excessive, the tendon should be replaced. If II strands fail, the displacement is about three times the original displacement. Since this is an unstable condition, the shim displacement should never be allowed to approach this value. Also, any loss in pre-load between maintenance intervals should be recorded: if the cumulative loss in pre-load becomes significant, the tendon should be replaced.

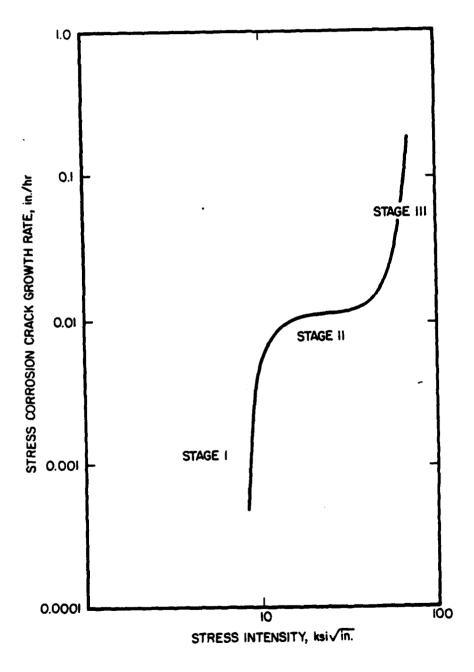
Figure 5. The effect of stress intensity at crack tip on crack growth rate.
